2011 STUDY OF THE LONG ISLAND CREEK WATERSHED: SANDY SPRINGS, GEORGIA
Directed by Dr. Mark Patterson and Dr. Nancy Hoalst-Pullen

June 28, 2011

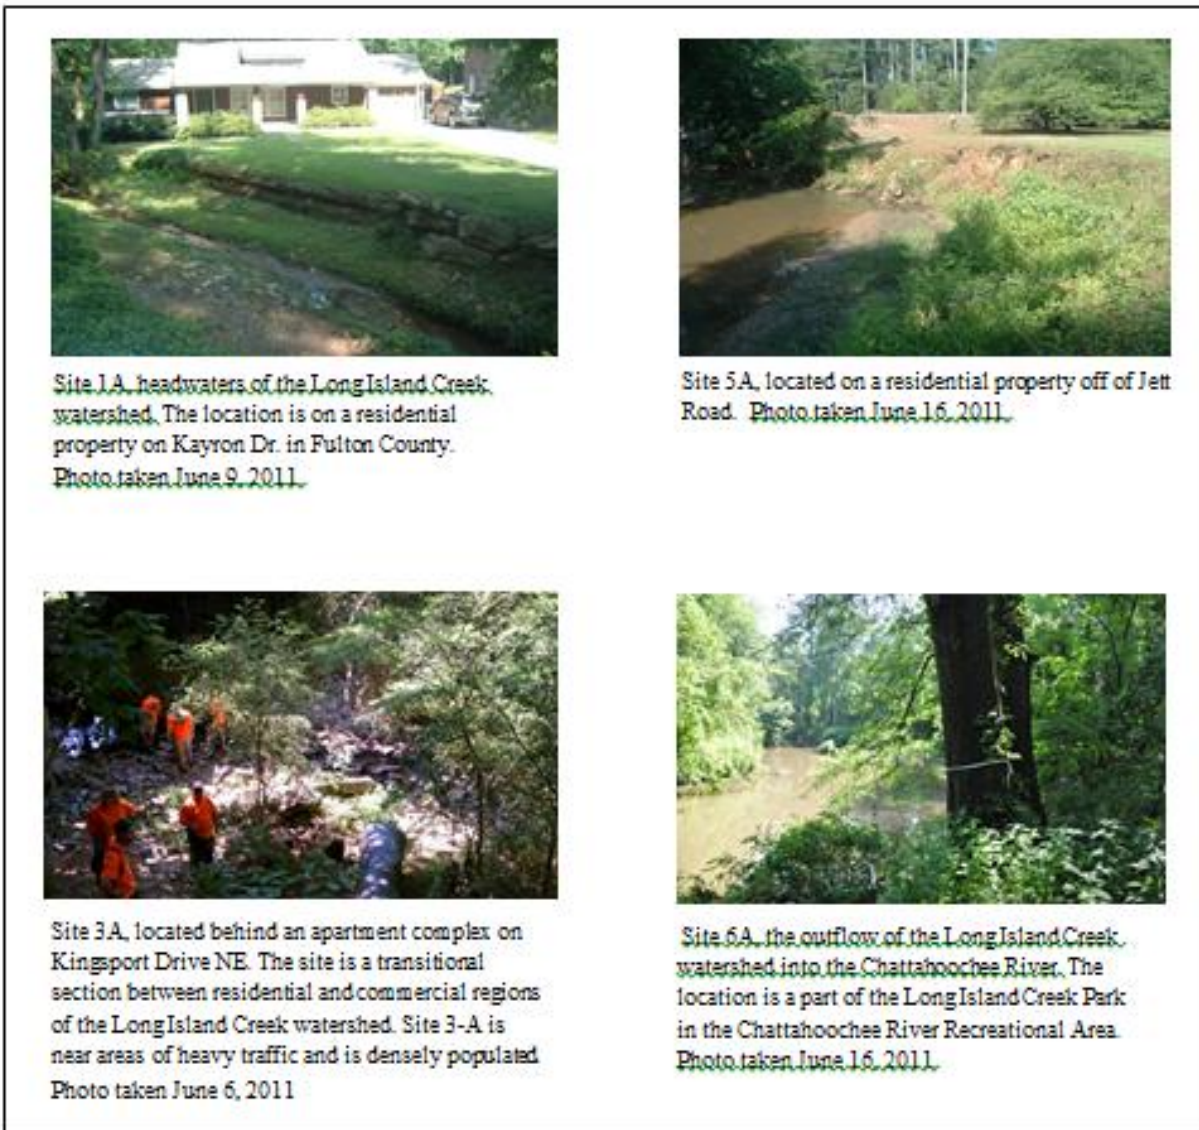
Figure 4: Photos of Site 1A, 3A, 5A and 6A

Area before the creek flows into the Chattahoochee River. This compares to the previous study performed in 2001 (Harper, 2001). Figure 4 shows various pictures representative of the watershed as it transitions from the urban upstream to the forested downstream.

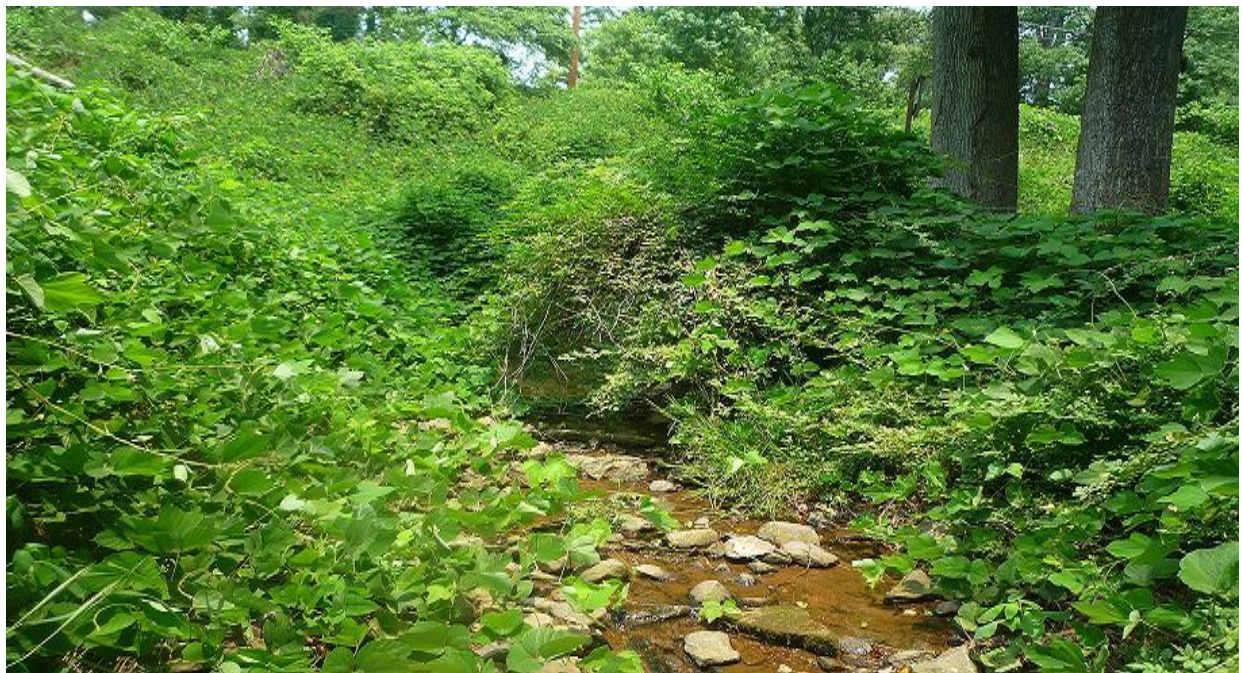
Site 2, June 21, 2011

Site 2 is located off of Hildebrand Road in Sandy Springs. Throughout the sites there were a number of factors that impacted the watershed such as a residential road, commercial land use close by, multiple domesticated animals, sewer drains and a large culvert, which linked the two sites together. Overall site 2 of the Long Island Creek Watershed had an average of 24.51 % of impervious surface. Nitrate levels around the area had an average of 0.63-0.88(mg/L). Phosphate level averaged <1 for both locations, and *E. coli* was measured and showed three different levels which were 633, 4133, and 1733(cfu/100mL).

Upon examining site A which is located along a residential road, the group discovered that the homeowner closest to the stream had at least five larger breed dogs, which were constantly found outside while doing this study. The dogs were found to be of importance in that the fence was located within five feet of the stream at some points, which contributes to large amounts of fecal matter being deposited into the streams after a heavy or light rainstorm. Site analysis revealed a large sewer pipe that runs directly along the middle of the stream. Although the pipe did not seem to have any obvious breaks or leaks, the pipe looked fatigued and rusted and in some points had a large covering of algae/slick substance. Over the course of the next few years, this pipe may need to be changed in order to keep sewage from interring the stream due to breakage and fatigue. The large culvert located on this site appeared to be in good shape, however there were a few areas that had obviously been exposed to the elements over the years and were starting to show signs of wear and tear i.e. corners cracked, discoloration on exposed sides, and large chunks of cement lying in bottom of culvert.

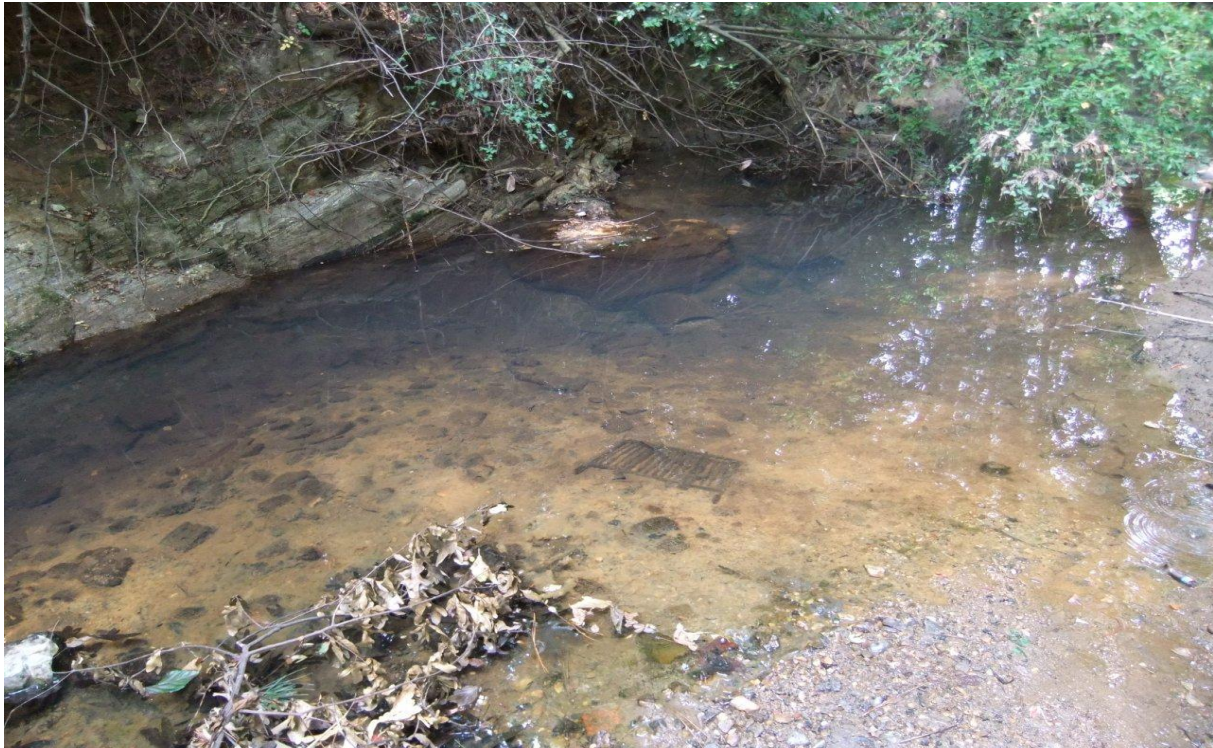
Site 3, June 16, 2011

Site 3 is located near the Interstate 285 and Roswell road intersection in the city of Sandy Springs. Site 3A is located in a heavy residential area. Its tributary is inside an apartment complex. The apartment complex and surrounding stores create much run-off towards the stream. Compared to site 3B it is easy to see the quality of drainage in this complex is lacking some needed safety precautions that would insure a healthier watershed. Site 3A is completely surrounded by impervious surfaces and no doubt is a contributor to the highest percentage of impervious surface in the Long Island Watershed (Table 1). There is cement, black top, or parking areas close the natural beauty of the site (Figure C1). The land use in this area did not seem to take nature into account when the planning and development was taking place and that fact is readily apparent when viewing the surroundings of the site and nature's benefits of the human occupation. The site is located underneath a bridge (Figure C1). The fact of the location being near a bridge creates a concern for sedimentation and siltation. The bridge is supported by steel pillars anchored in cement, which only adds to the already encroaching imperviousness that dominates this site. The site is compromised by the bridge in other ways as well. It seems the site is already being used as a dump by some local residents, but the bridge adds more to that litter pile. Table 3 shows evidence of this with the levels of *E. coli* being the 3rd highest in the Long Island Watershed. Figures 11 and 12 shows more of the impact humans have had on this location giving light to pH levels and conductivity respectively, which has to do with mineral and metal content, being tied for the highest in pH and the highest in conductivity out of all Site locations in this particular Long Island Watershed Study. There is an extreme drop-off where the flood-line appears to be and much steepness and unsettled terrain where the bank-fall lies (Figure

C3). This shows factual evidence of much erosion and massive run-off problems. There is no surprise in that fact when in observance of the sparseness of vegetation near the base and bank line. Trees near the stream are in peril. Some are infested with centipede colonies, others with cankers full of cancer, and still more almost completely decaying with little chance of recovery (Table C1). Each day there was new trash in the stream itself from ceramic dishes to children's bicycles to broken aquariums and then still broken glass highlighting the shore like sand covering a beach.

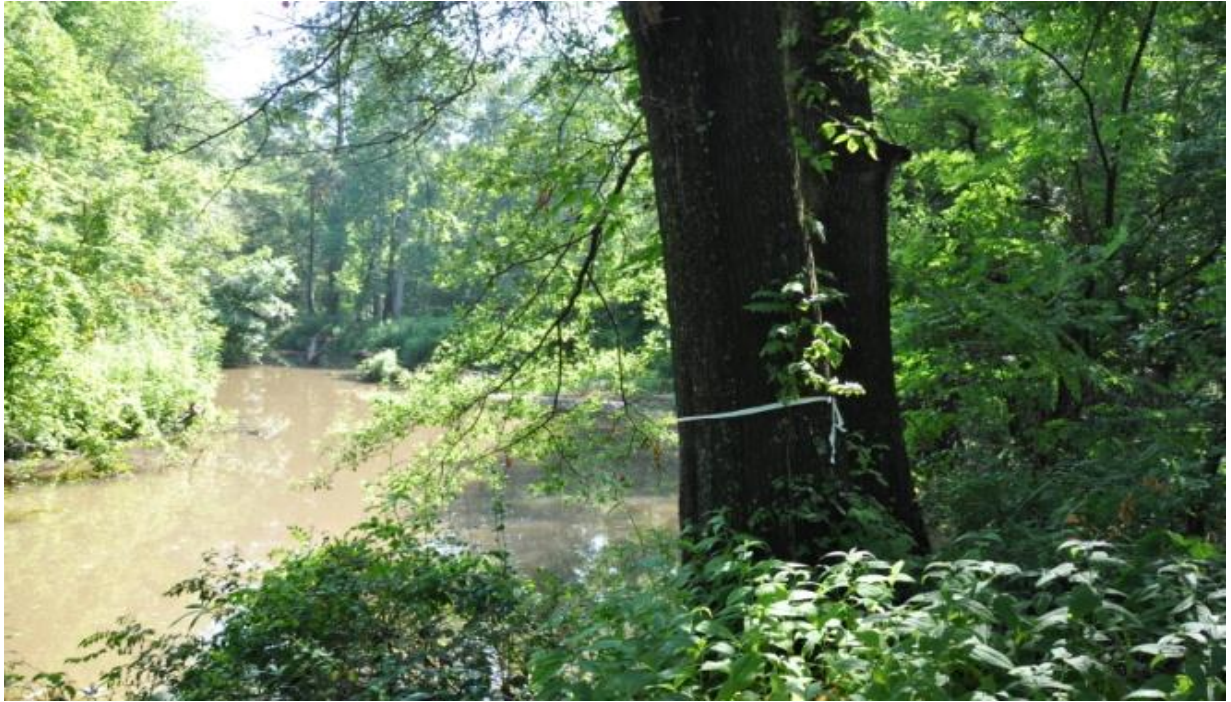
Site 6, June 21, 2011

Though human impact is limited, nature has not been as kind, recent storms and flooding have left evident damage to the local ecosystem. Numerous fallen mature trees of various species can be observed within the sample site areas with signs of exposed roots, leading to the belief that strong winds have plagued the area. The increasing urbanization surrounding the watershed and an increase of impervious surface area is suspected to be the cause of frequent flash flooding and runoff. The stream susceptibility to flash flooding has led to severely undercut banks and increased sediment deposits.

The physical locations of the sampling sites in the watershed along with their characteristics are revealed in their test results. At site 6 there is an even distribution of riffles, runs, pools with a deep wide channel with steeply cut banks and a healthy riparian zone with a wide diversity of trees, and groundcover. The banks are completely free of riprap or any type of bank restoration or stabilization. This is unusual since the banks are heavily undercut and in many places are commonly found to be very unstable.

The next step to be taken is to locate the sources of this pollution. Once located, measures can be taken to reduce or eliminate the pollution. Some of the ways that can be done is to reduce the impervious surfaces around the immediate area of the stream. That will decrease surface runoff into the stream. Another option would be to limit and monitor any pipes or dumping that could be releasing harmful chemicals into the stream. Bank erosion also needs to be prevented to protect the stream and the plant life around it. Many trees are being severely threatened and have a high risk of failure. In a few years, one could most likely see a lot of fallen, close to falling or dead trees because of severe undercutting taking place along the bank.
